NYX DIAMOND WALL RESET - ELECTRICAL & LIGHTING TROUBLE SHOOTING GUIDE

DW 2.0 ⇨ DW 2.1

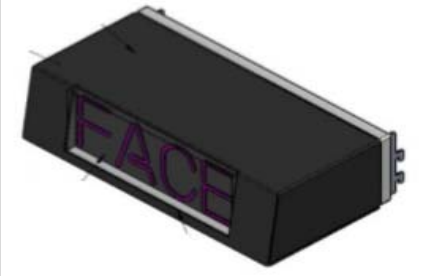
CATEGORY SIGN ISSUE		CHECK	PROBABLE CAUSE	REMEDY
CATEGORY SIGN IS NON LIGHTING

→ CHECK IF CATEGORY SIGN IS CORRECTLY ATTACHED TO BACK WALL SLOTS	→ SOME HOOKS ARE NOT FULLY ENGAGED INTO THE BACK WALL SLOTS	→ CAREFULLY LIFT THE SIGN UPWARDS AND RE-ATTACH TO THE BACK WALL SLOTS - ENSURING ALL HOOKS ARE FULLY ENGAGED.	
		→ ALL HOOKS APPEAR TO BE FULLY ENGAGED INTO THE BACK WALL SLOTS, HOWEVER THERE IS A CLEAR PROTECTIVE FILM APPLIED TO THE FRONT FACE OF THE BACK WALL PANEL.	→ CAREFULLY REMOVE THE SIGN AND SET ASIDE. PEEL OFF THE PROTECTIVE FILM FROM THE BACK WALL PANEL. REPLACE THE UNIT ONTO THE WALL - ENSURING ALL HOOKS ARE FULLY ENGAGED.	
		→ ALL HOOKS ARE FULLY ENGAGED INTO THE BACK WALL SLOTS, THERE IS POWER TO THE COLUMN....STILL NO LIGHT.....	→ CONTACT CUSTOMER SERVICE HOTLINE FOR FURTHER ASSISTANCE - 1-877-256-7325
